# TEST REPORT

## PF25075

### Pilot scale fire resistance test for the doorset hardware variation

| Client: | <b>LSC NZ Limited</b> |

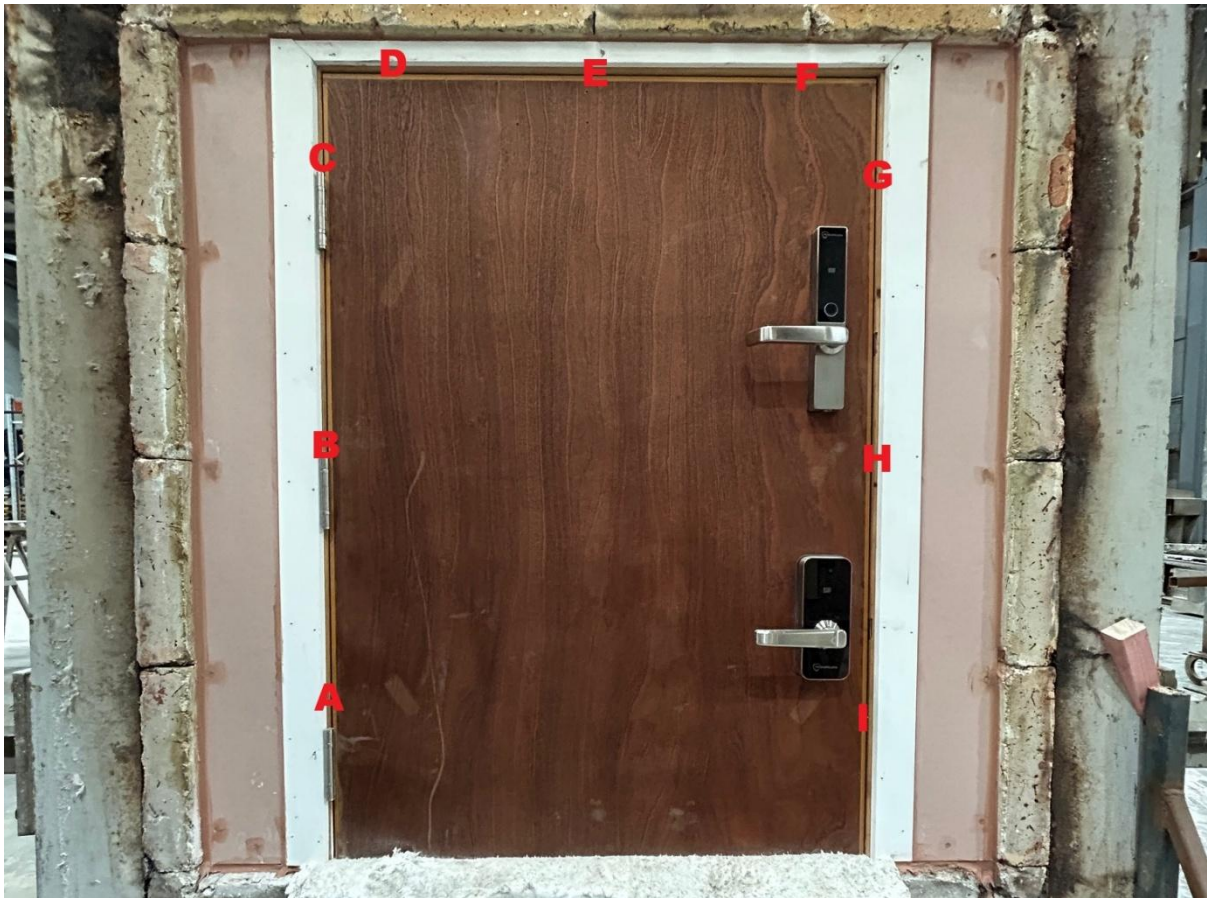
**Figure 1 – Gap Measurement Location**

Gap Measurement from exposed face:

| A – 2.5mm | B – 2mm | C – 1.5mm | D – 2.5mm | E – 2.5mm |
| F – 3mm | G – 2.5mm | H – 3.5mm | I – 4mm | |

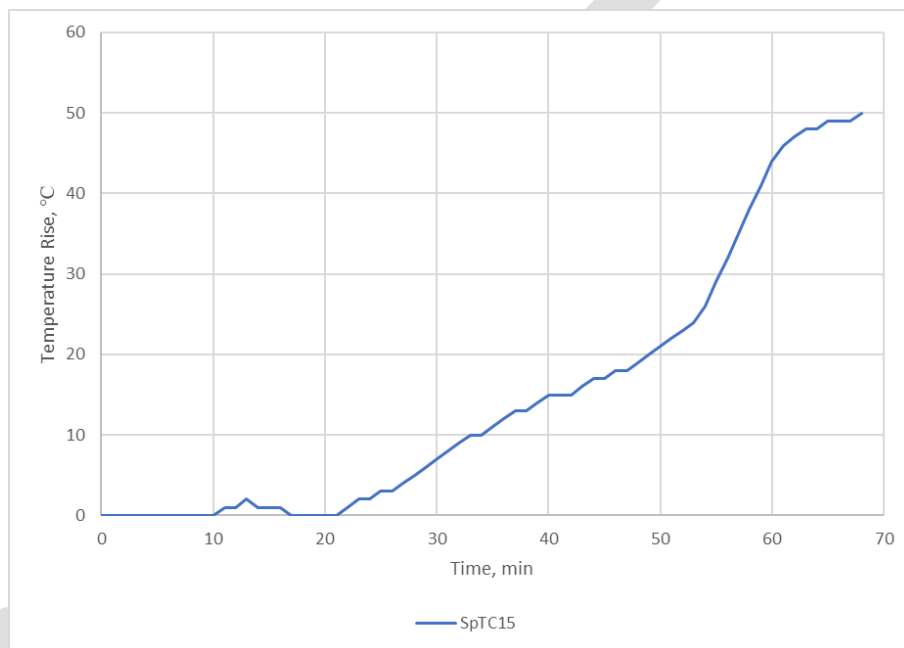
**Figure 9 – Maximum temperature of the door leaf 100mm away from the Lock**

| Test results | |
|---|---|
| Integrity | No failure at 68 minutes |
| Insulation | No failure at 68 minutes |

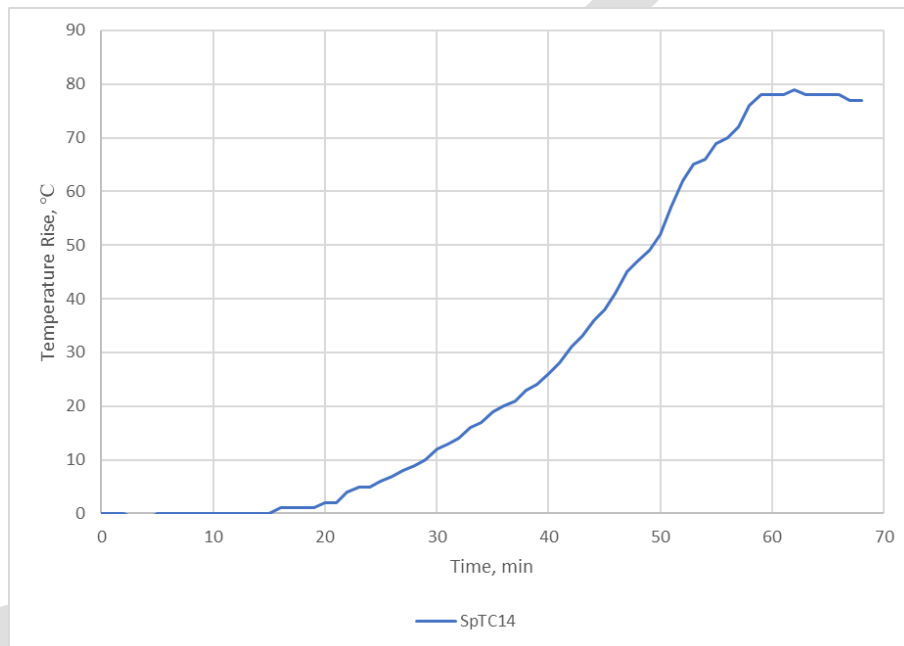
**Figure 10 – Maximum temperature of the door leaf 100mm away from the lock**

| Test results | |
|---|---|
| Integrity | No failure at 68 minutes |
| Insulation | No failure at 68 minutes |

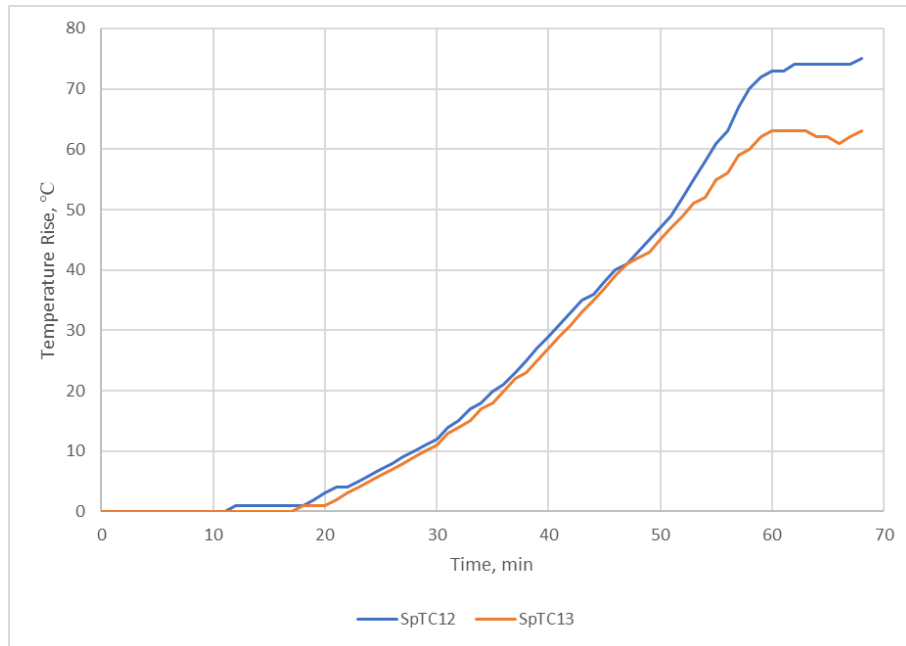
**Figure 11 – Maximum temperature of the door leaf 100mm away from Door Closer**

| Test results | |
|---|---|
| Integrity | No failure at 68 minutes |
| Insulation | No failure at 68 minutes |

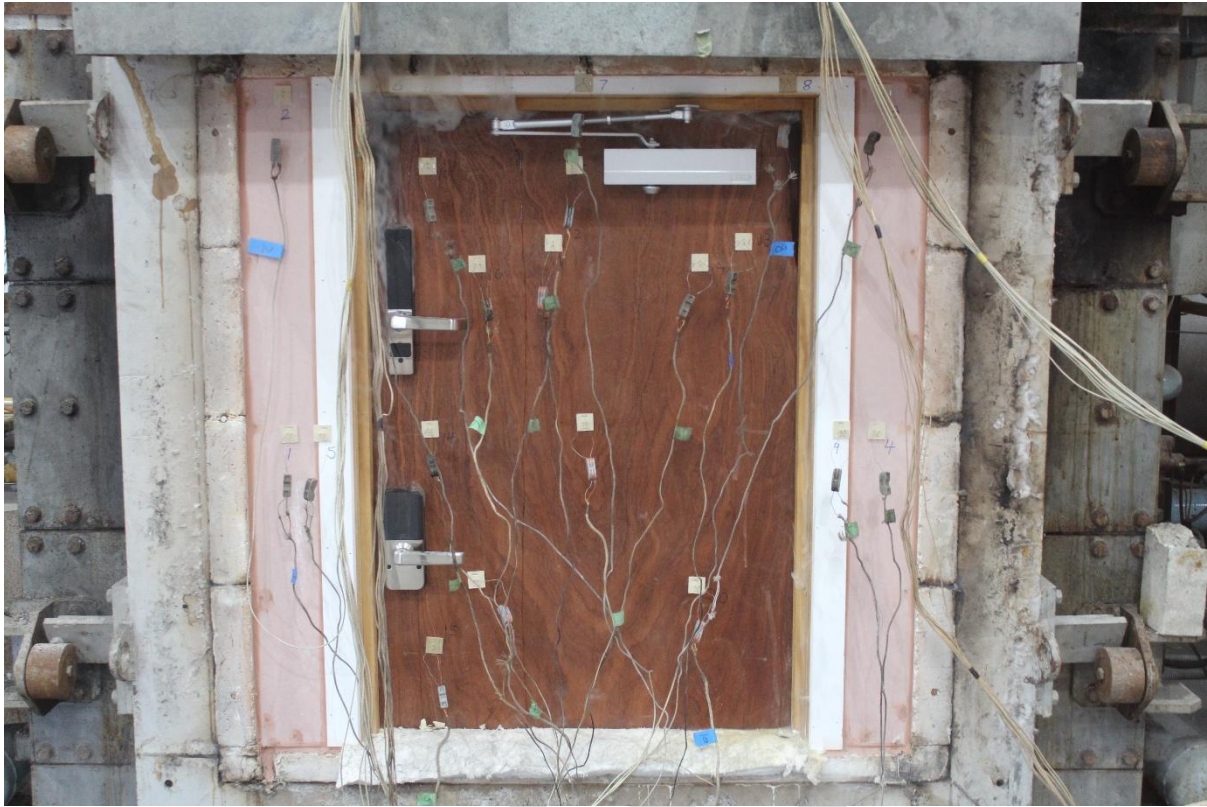
**Figure 21 – Unexposed face at 15 minutes**

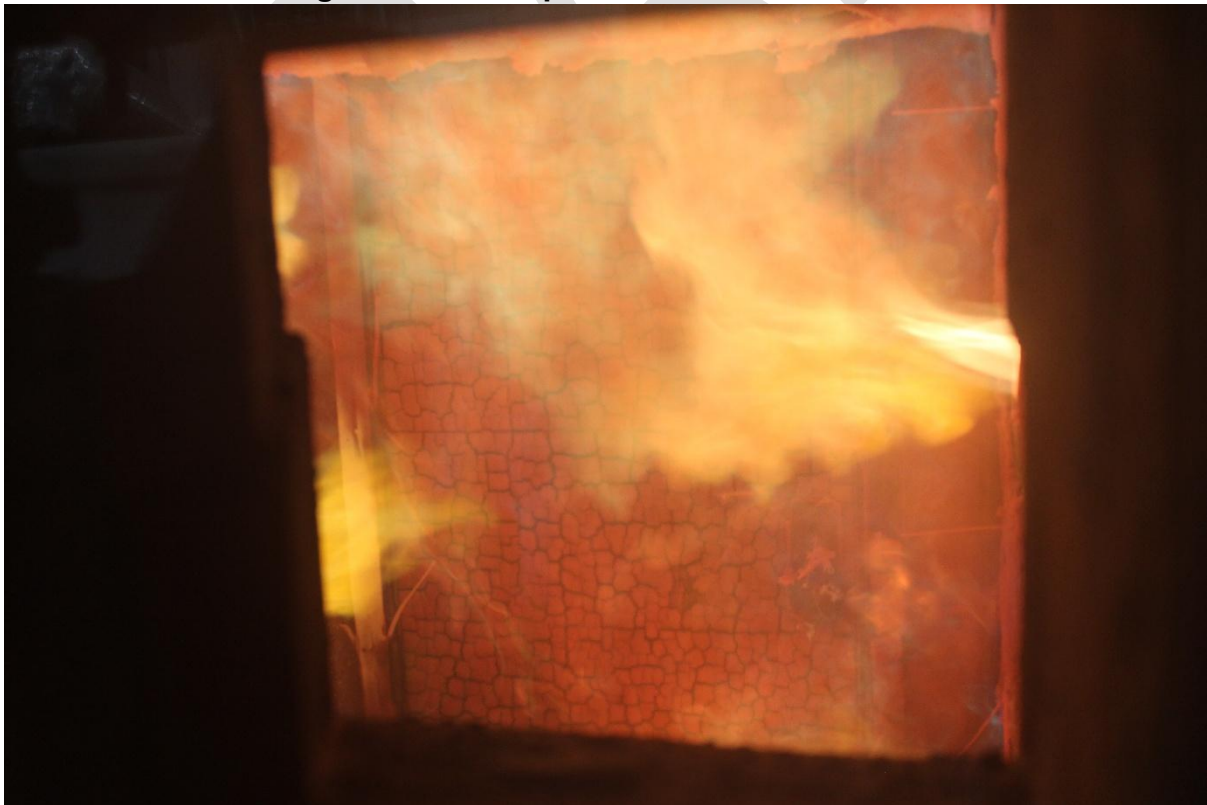
**Figure 22 – Exposed face at 15 minutes**

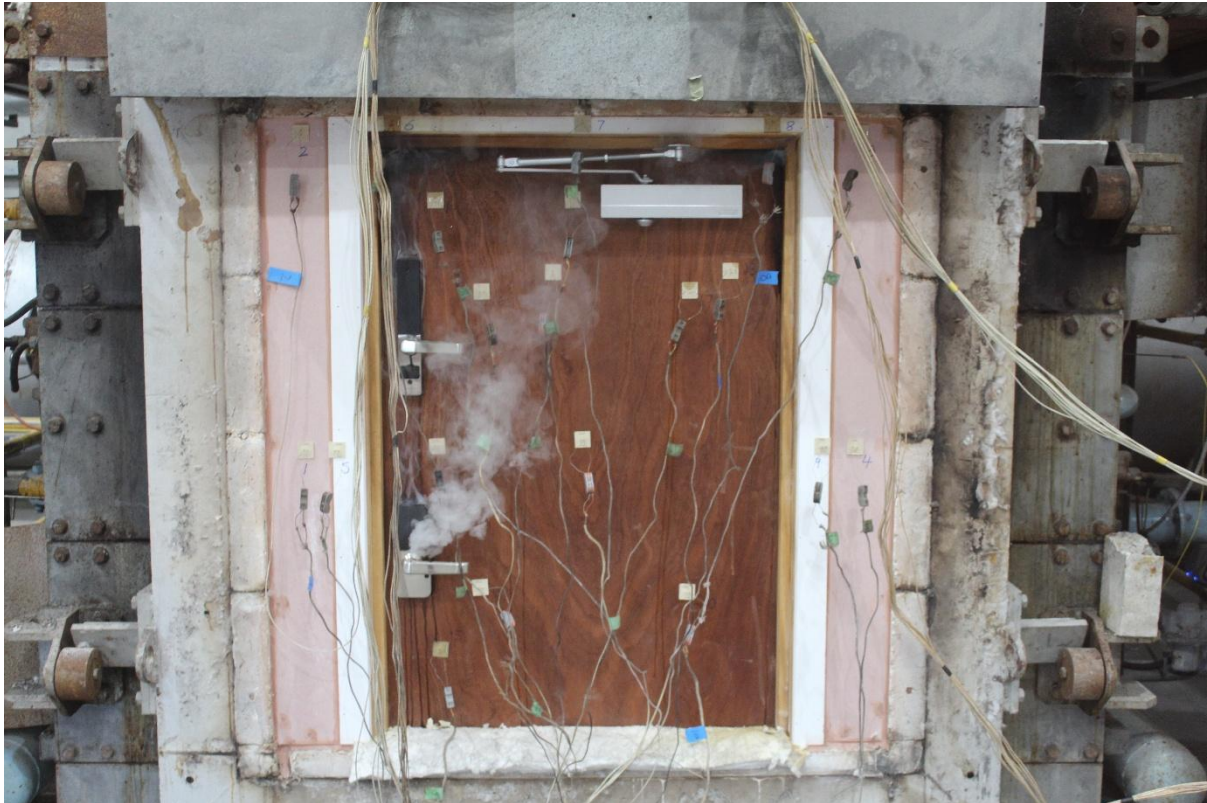
**Figure 23 – Unexposed face at 30 minutes**

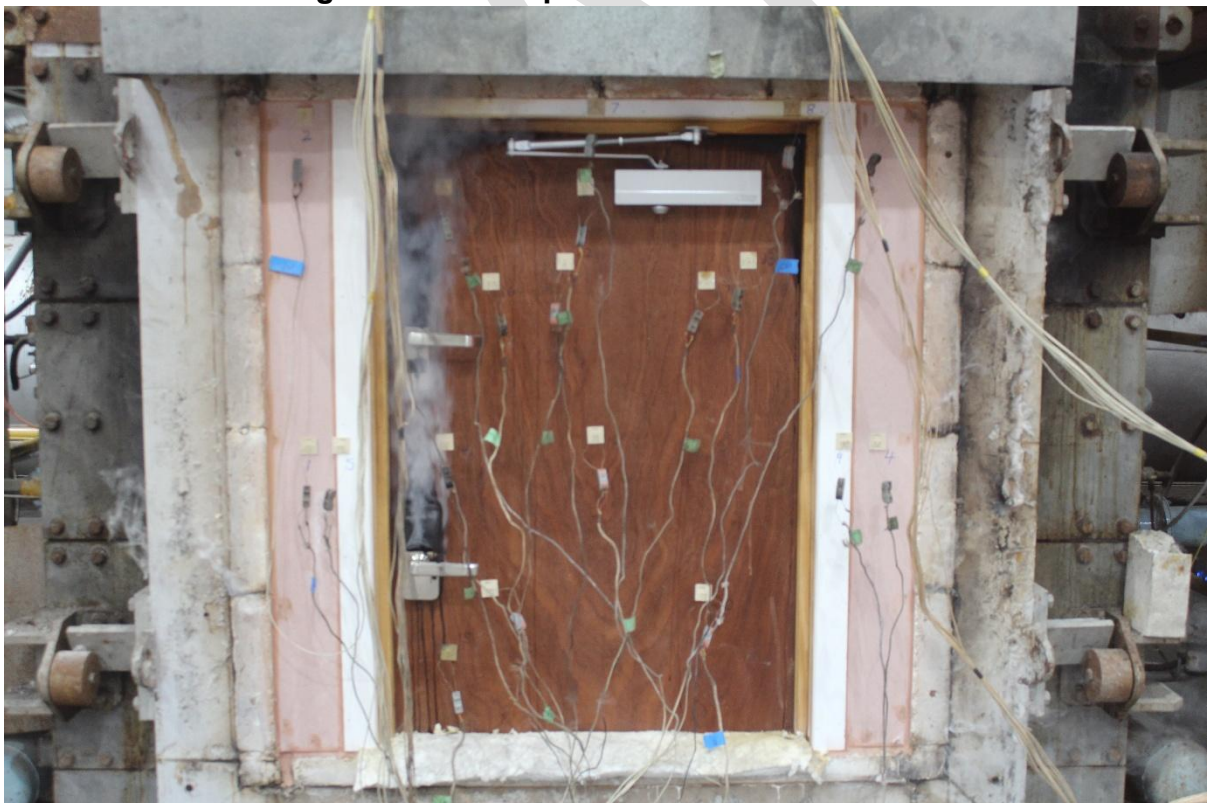
| Time min | Test face | SP# | OBSERVATIONS/REMARKS |
|---|---|---|---|
| 45 | U | B | The plastic cover of the lock furniture melted. |

**Figure 24 – Unexposed face at 45 minutes**

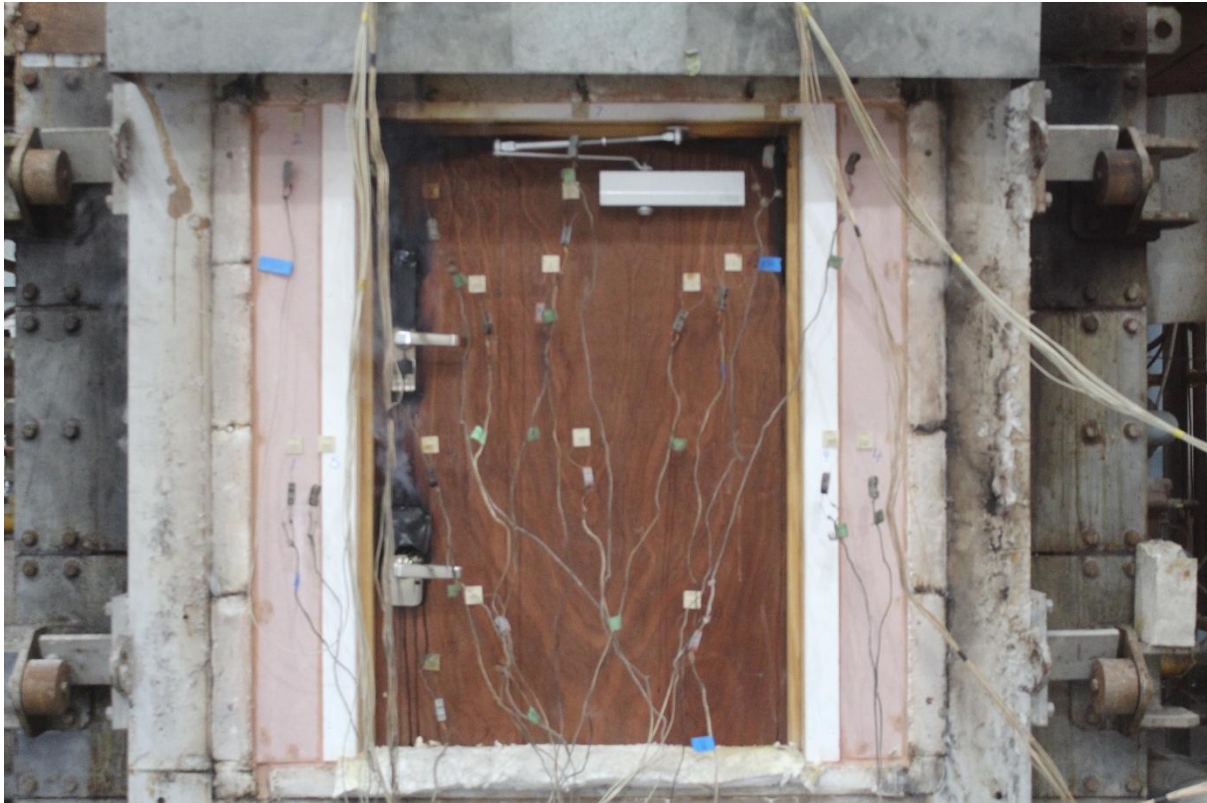
| Time min | Test face | SP# | OBSERVATIONS/REMARKS |
|---|---|---|---|
| 53 | U | A | Discolouration was observed on the door leaf in the areas around both lock furniture. |
| 59 | U | A | The plastic cover of the lock furniture melted. |

**Figure 25 – Unexposed face at 60 minutes**

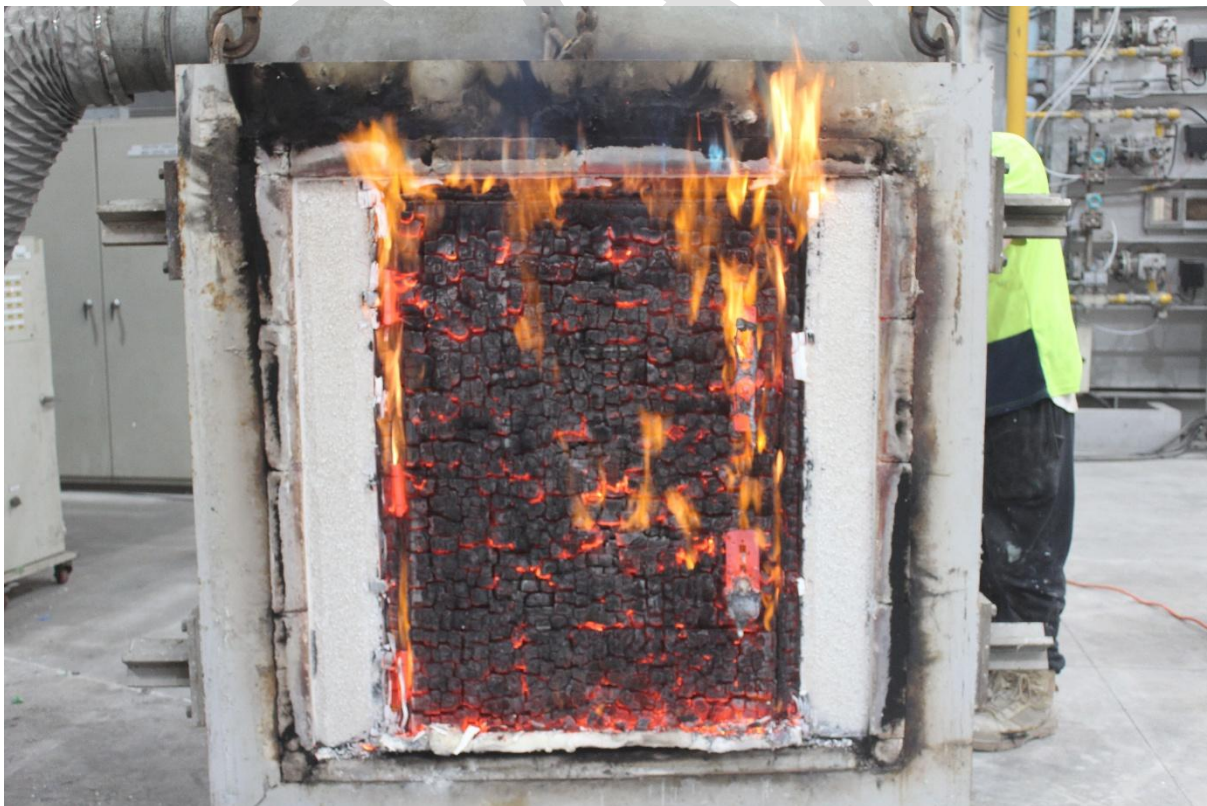
| Time min | Test face | SP# | OBSERVATIONS/REMARKS |
|---|---|---|---|
| 12 | E | B&C | Handles detached from the lock furniture. |

**Figure 26 – Exposed face after the test**

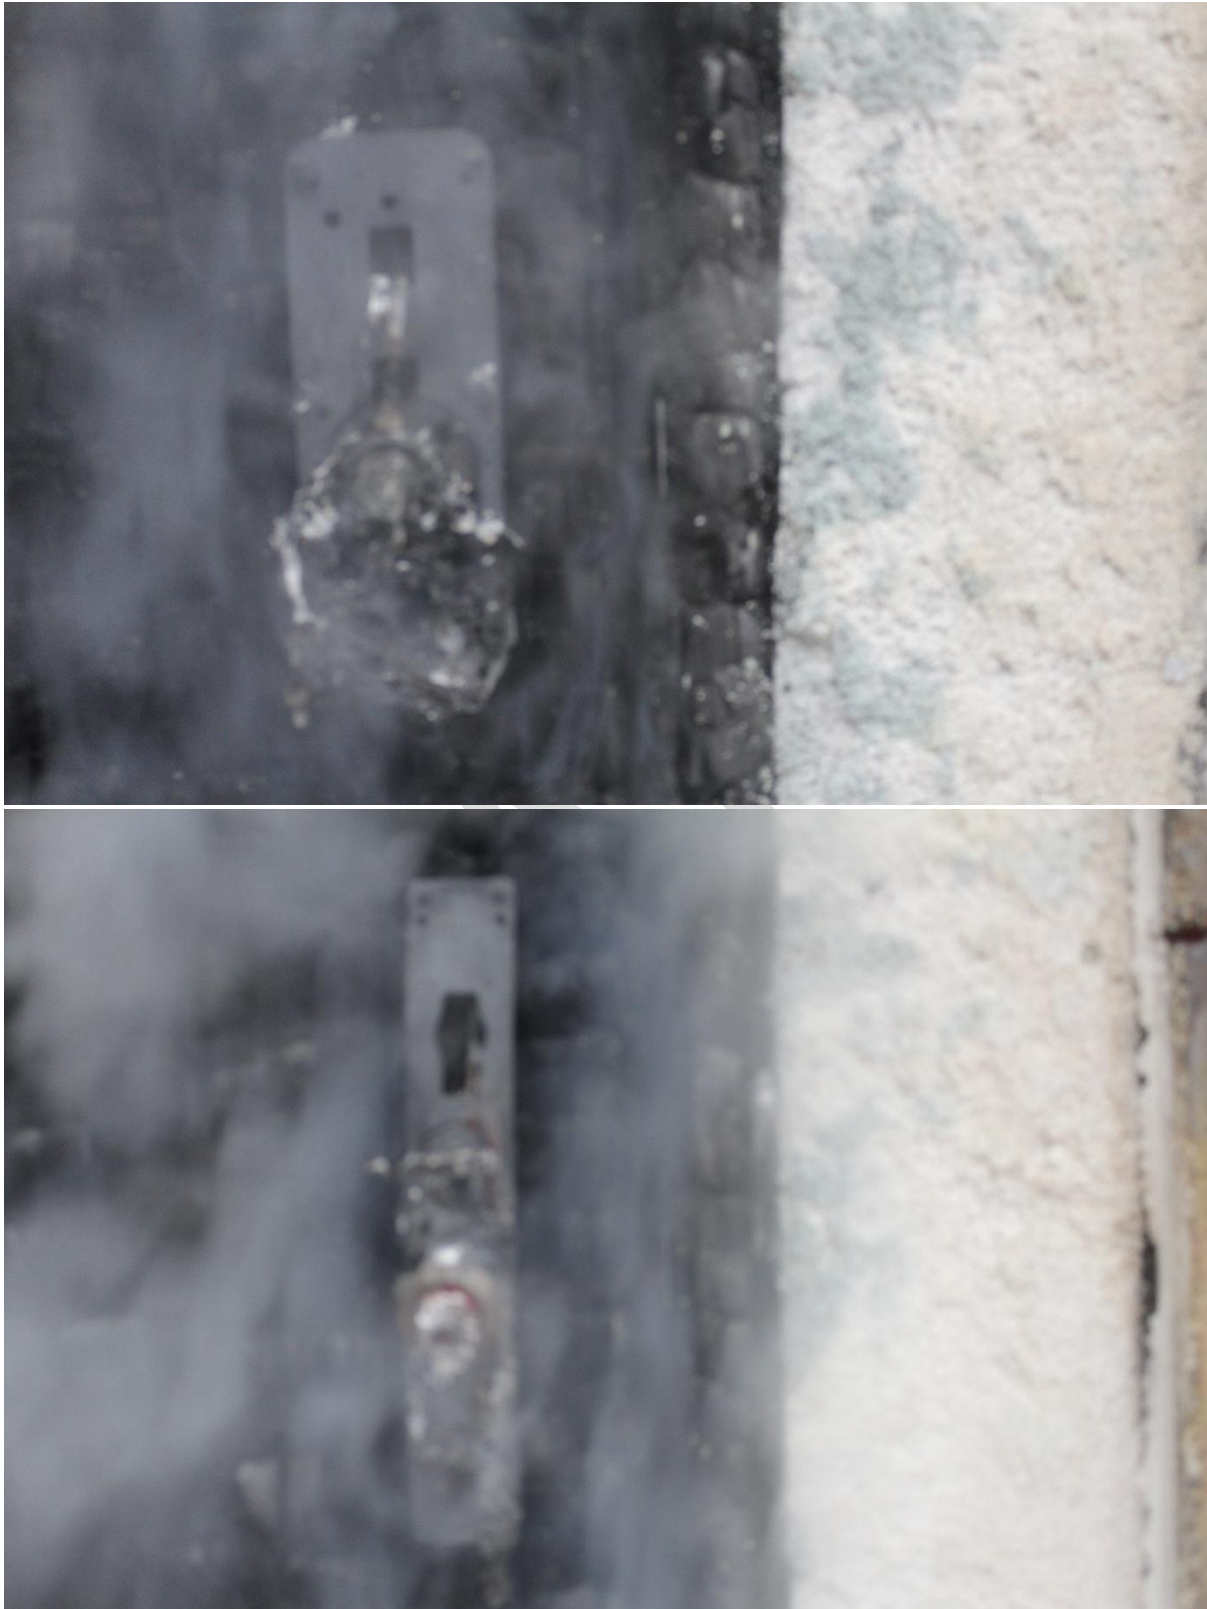
| Time min | Test face | SP# | OBSERVATIONS/REMARKS |
|---|---|---|---|
| 68 | | | <b>TEST DISCONTINUED - Latch mechanism still visibly engaged.</b> |

**Figure 27 – Latch mechanism after the test (Still engaged)**
